**DETAILED TREE  
ASSESSMENT**

Sycamore 30708 at  
Rodway Common

July 2024

**Barton Hyett Associates**  
Arboricultural Consultants

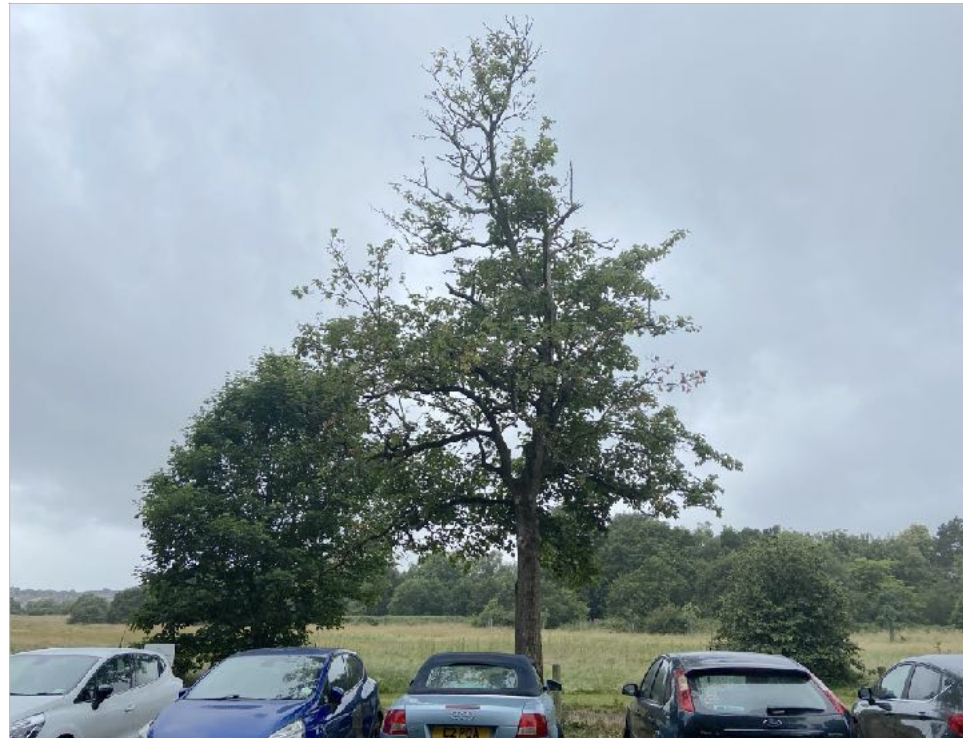
IMAGE 1: View of sycamore 30708 looking west from the highway.

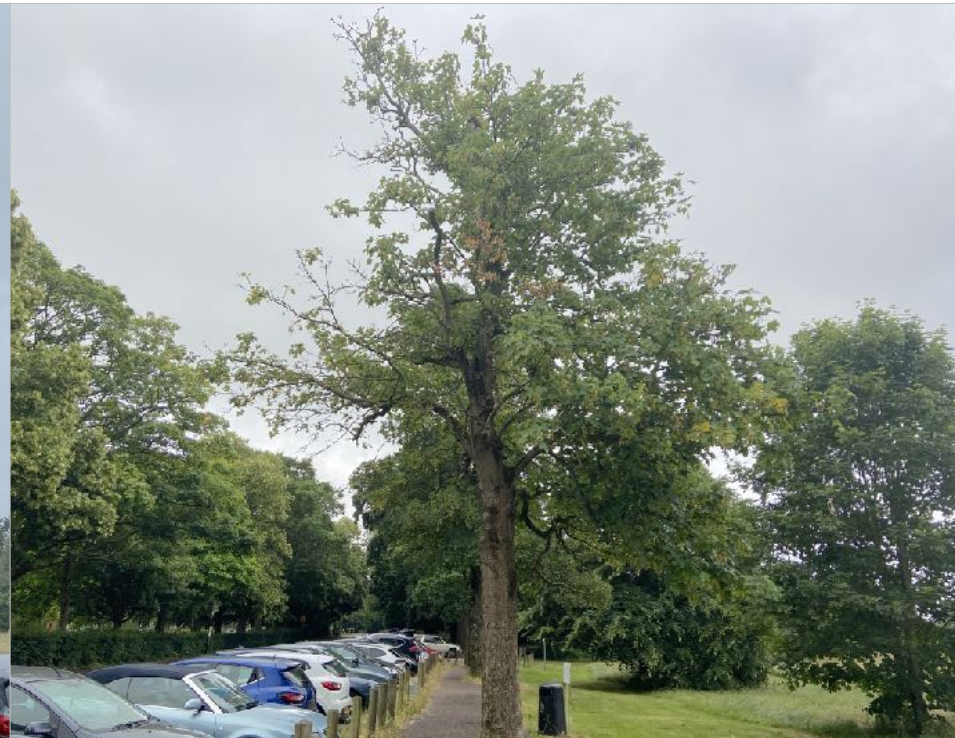
IMAGE 2: View of sycamore 30708 looking south.

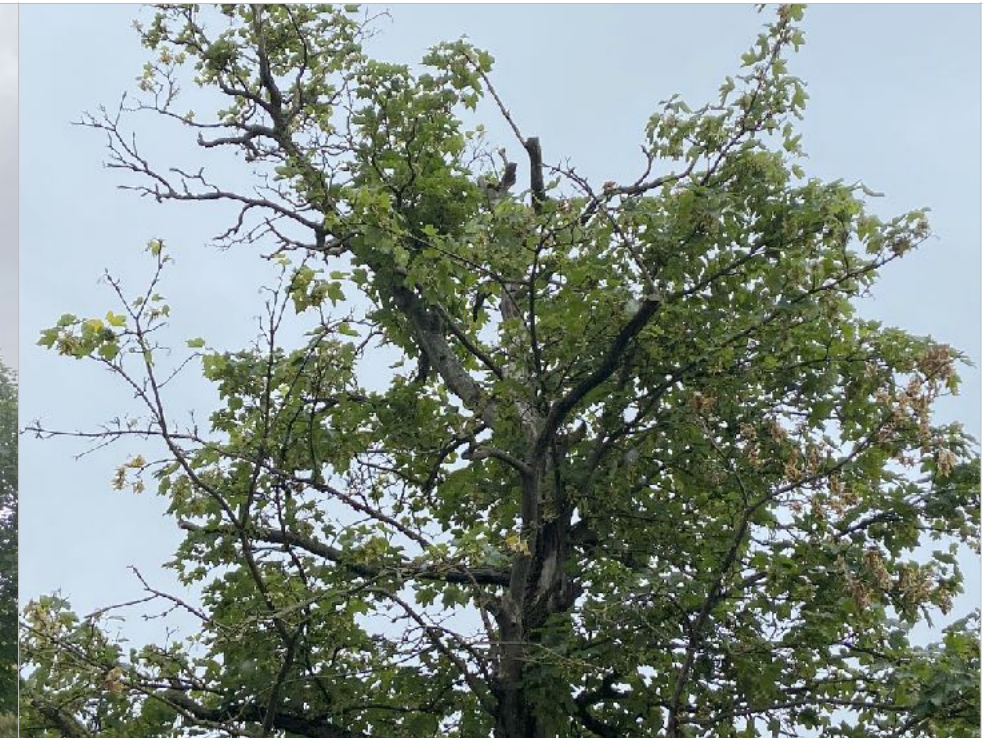
- 2.3. While height reduction to remove the upper part of the crown could rectify crown dieback in an otherwise stable tree, unfortunately, the fungal bodies are a significant indicator of decay in the trunk base and root system, with the potential to cause whole tree failure onto the path and parked cars.

IMAGE 3: Detail of the dieback in the upper crown, looking southwest.

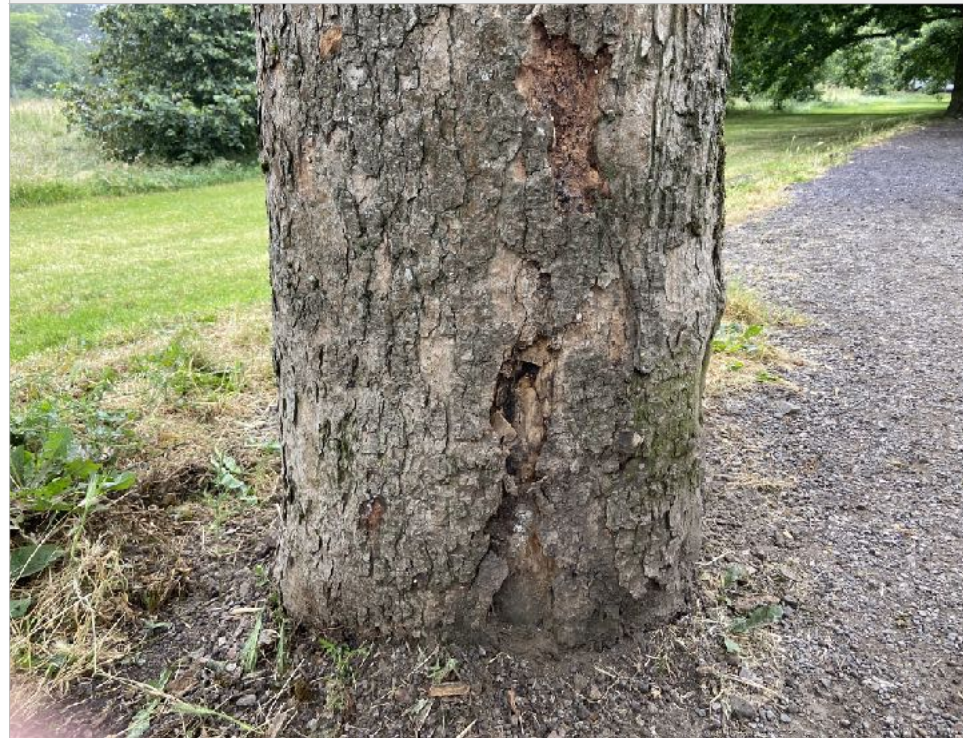
- 4.5. The depth of the path meant that it was impossible to locate and assess the tree's roots by hand excavation without significantly disturbing the path surface. However, decay is present around the trunk base below the level of the path and extends above the path level on the southern side of the trunk. The extent of decay suggests that principal roots are likely to be affected. Decay within the root system is particularly unpredictable because it cannot easily be assessed. *Kretzschmaria deusta* fungus is frequently associated with the failure of trees and roots.

IMAGE 4: Detail of the southern side of the trunk base.

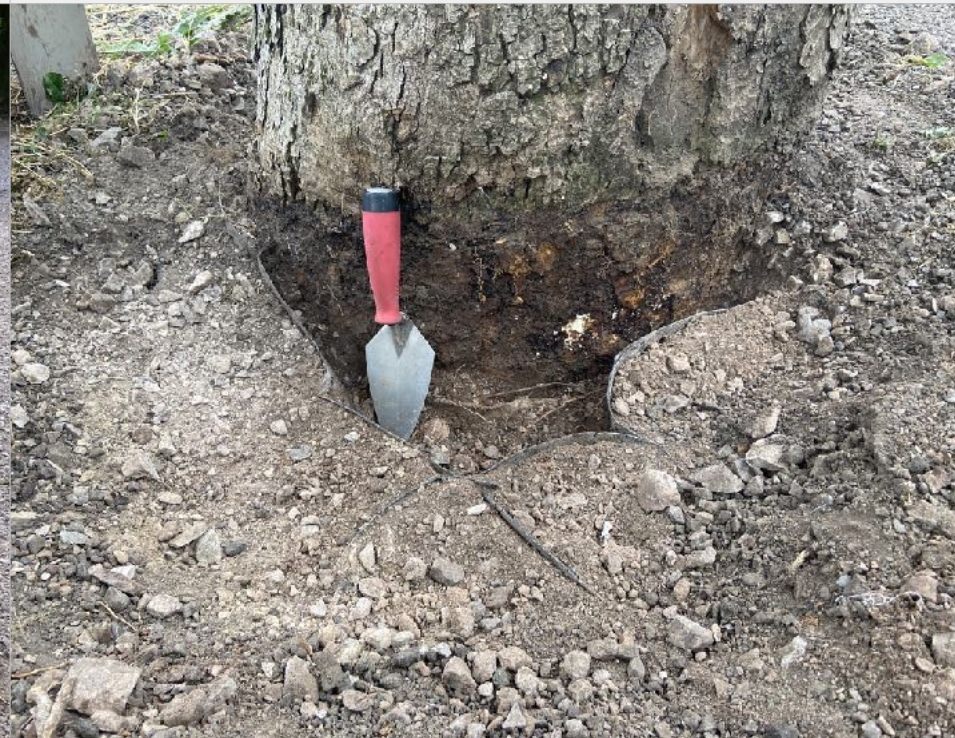
- 4.4. The path has been built around the tree to some 20-30cm depth, burying the trunk base and probably leading to decay by causing stress to the root system and root death. Although the path has been constructed using a 'cellweb' system (the intention being to avoid compaction and maintain gaseous exchange with the root system), unfortunately, the cells (visible in images 5 and 6 in **Section 3**) have been filled with standard compacted road stone with dust, instead of washed gravel, which has defeated the object of using the cellweb.

IMAGE 5: The excavated path surface to the south side of the trunk.

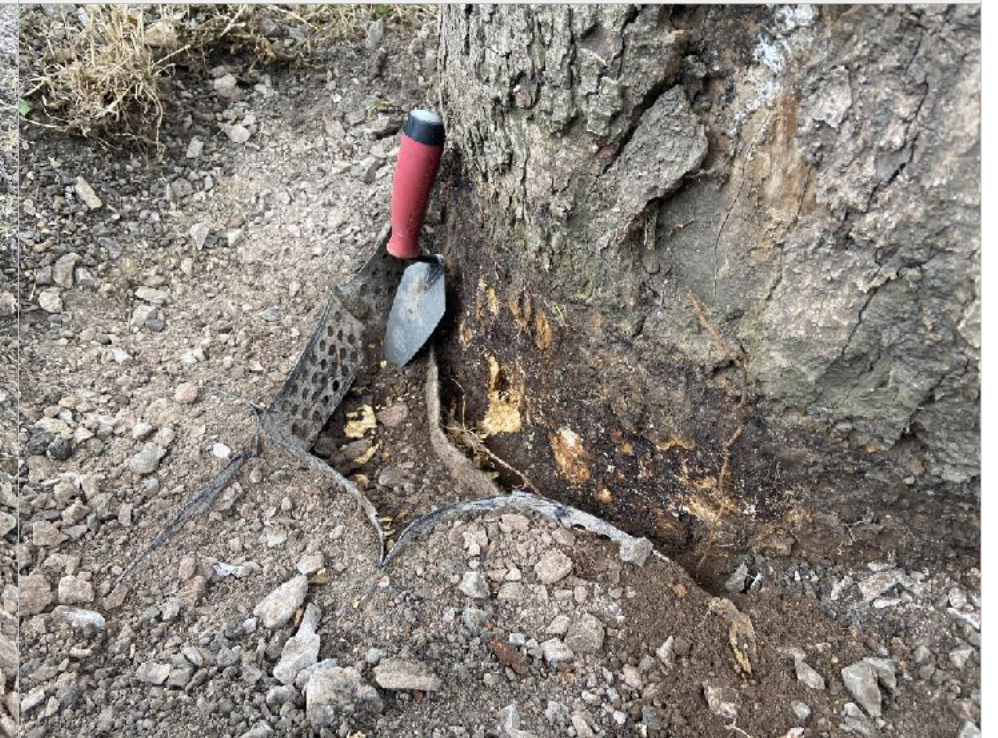
IMAGE 6: The excavated path surface to the south side of the trunk.

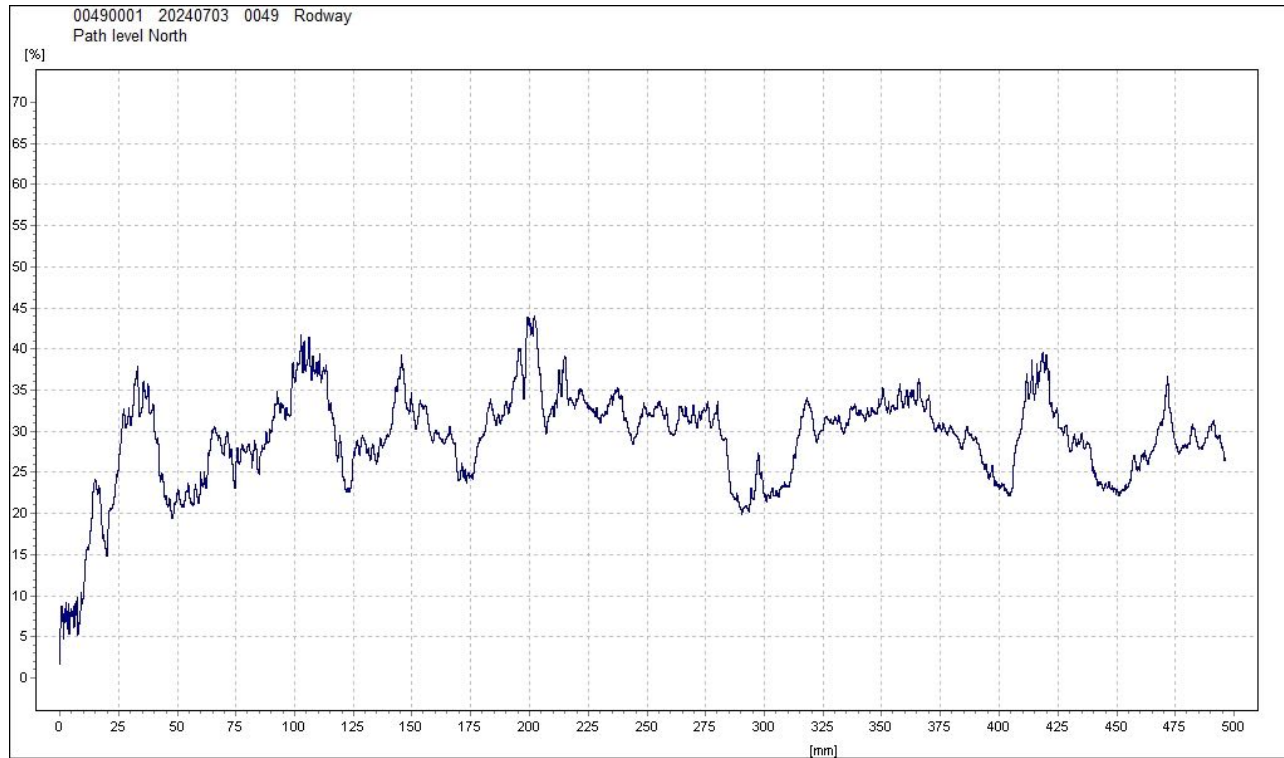
**GROUND LEVEL NORTH**

- 4.2. The readings for the sycamore instead show complex but advanced decay, with little in the way of sound wood. The only obviously sound wood is shown in the eastern reading from 35mm to 110mm depth, where the reading peaks are fairly uniform. Other pockets of sound wood may be shown, but decay is present at varied depths on all four readings.

- 4.3. These uneven variations of wood density reflect complex decay of the type caused by *Kretzschmaria deusta* fungus - a type of 'simultaneous white rot' that can lead to brittle ceramic-like fracture of the root system. The crown dieback symptoms are also consistent with this type of decay.

- 6.1. From the information obtained from the resistograph assessment of sycamore 30708 and the observations made by hand excavation at the base of the tree, I conclude that the risk of harm from whole tree failure is Unacceptable. The tree should be felled.
